Evaluation Report

Orca AI Computer Vision Assessment

Project no. : 2409-0018

July 2025

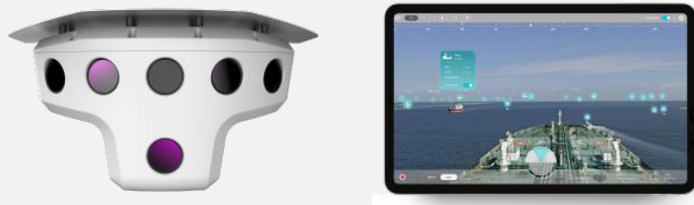
Orca AI SeaPod

The SeaPod features a fixed sensor head positioned near the ship's centre line, equipped with five optical cameras (FOV 225°) and three thermal cameras (FOV 100°). It employs AI-driven technology for real-time detection, classification, and distance estimation of surrounding relevant maritime objects.

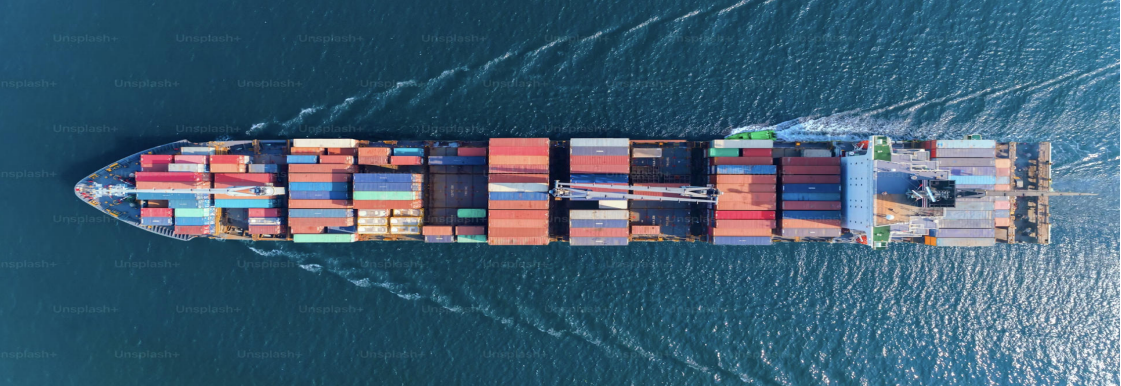
Vessel route during the evaluation

The evaluation was conducted on a container vessel over a period of five days. The vessel began its voyage in Gioia Tauro, Italy, proceeded to Bar, Montenegro, and concluded in Marsaxlokk, Malta, where the evaluation was completed. The voyage took place from 30 June to 4 July 2025, with clear weather observed throughout. The total distance covered during the evaluation is 828 NM.

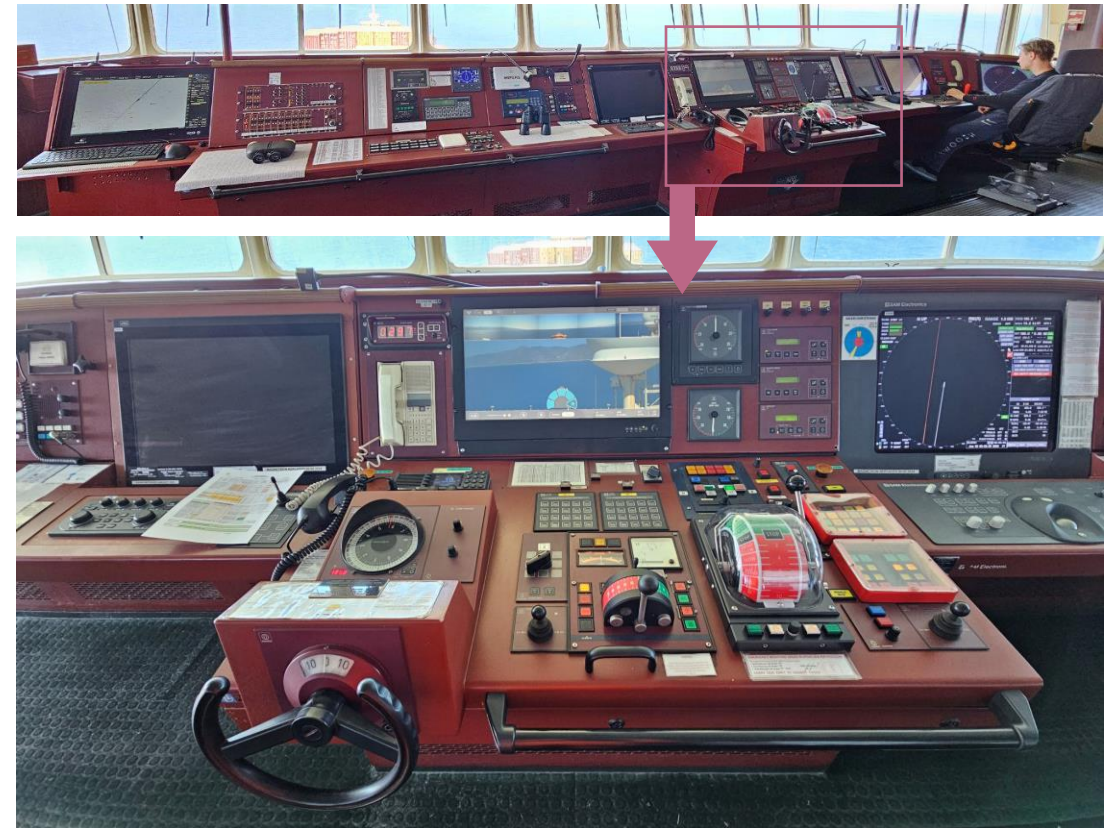
The Orca AI system's screen is centrally positioned on the bridge console, directly in front of the piloting officer.

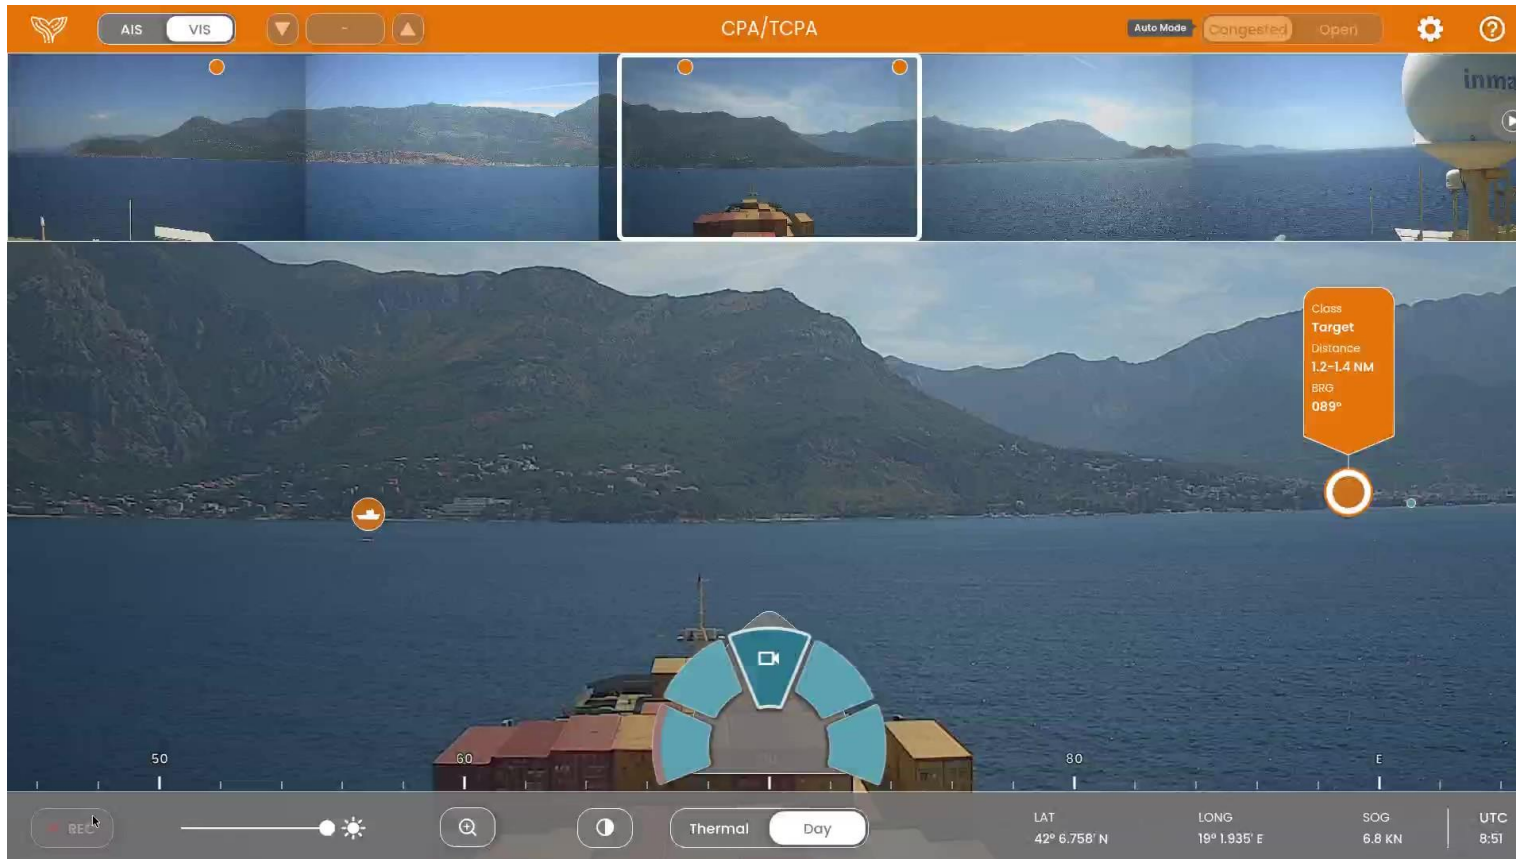
Orca AI System's Screen

The Orca AI System's interface displayed on the vessel's bridge console shows the day camera in use, with the centre camera selected as the primary focus. Both Visual (VIS) and Congested modes are activated in this instance.

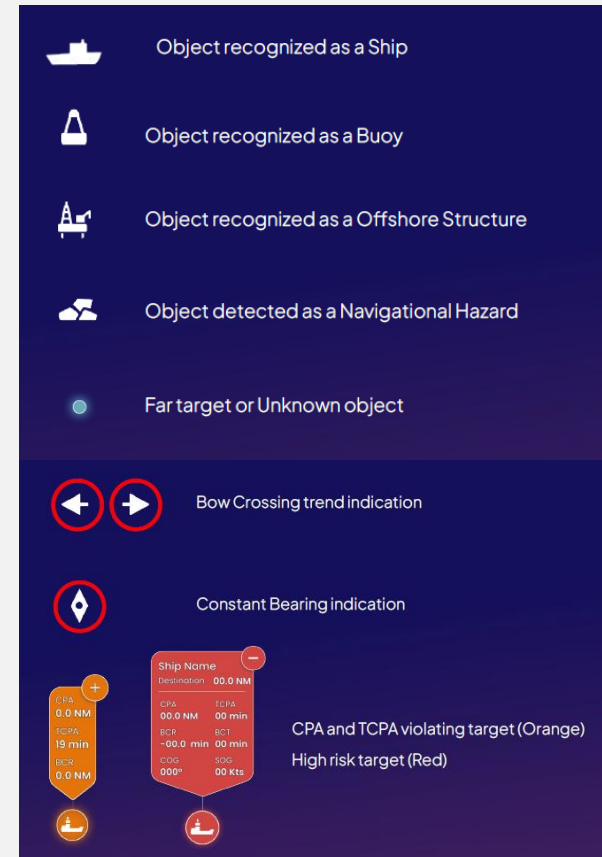
Classification & Indications

Symbols shown in Orca AI System's screen.
Source: Orca AI – SeaPod Training Booklet

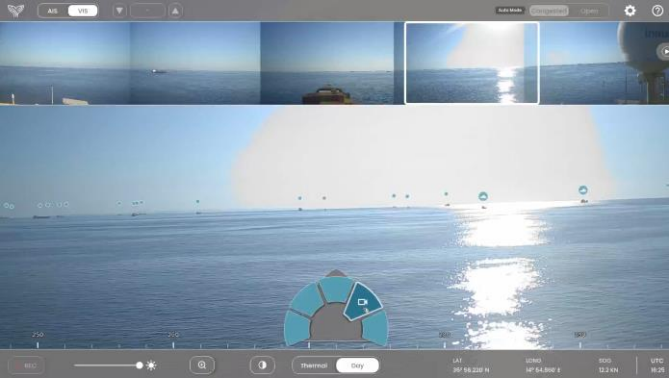
Orca AI System's Screen

Detections captured by the Orca AI SeaPod in visual mode have been recorded, with evaluations conducted across all cameras (five in day mode and three in thermal mode).

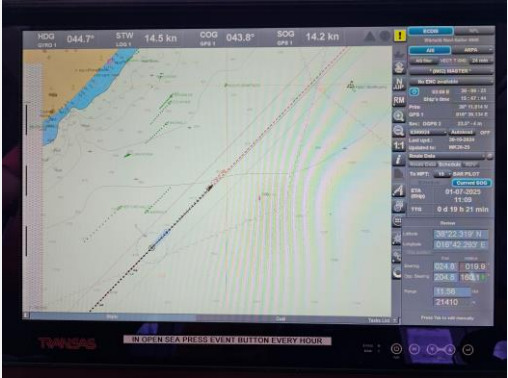
AIS (via ECDIS)

AIS data displayed on the ECDIS, including available information such as object type and reported distance, is utilised.

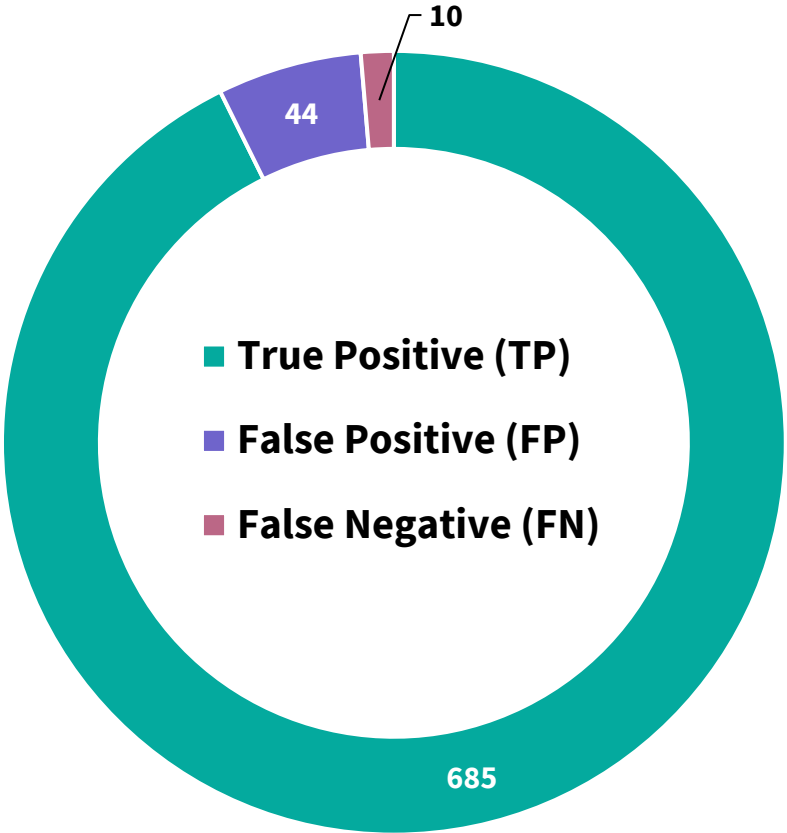
Detection Performance Distribution

The number of relevant targets during the evaluation is 739

Precision	Recall
94.0%	98.6%

- The evaluation of Orca AI’s Computer Vision system showed high Precision and Recall scores.
- The Recall score indicates that the system detected most relevant maritime objects during the evaluation, with an estimated missing rate of 1.4%.
- False Positives (FP) were observed primarily in two categories:
 - Duplicate detections of the same object.
 - Detections affected by visual conditions such as glare or reflections.Both types were included in the total FP count. Duplicate detections, which comprised approximately 73% of all FPs during the voyage, reflect repeated identification of existing targets rather than detections of non-existent objects.
- No system downtime was recorded throughout the evaluation period.
